STOUFFER'S INN OF WESTCHESTER

Harrison, NY

December 4, 1980

FIRE INVESTIGATION REPORT
STOUFFER'S INN OF WESTCHESTER
HARRISON, NEW YORK
26 FATALITIES
DECEMBER 4, 1980

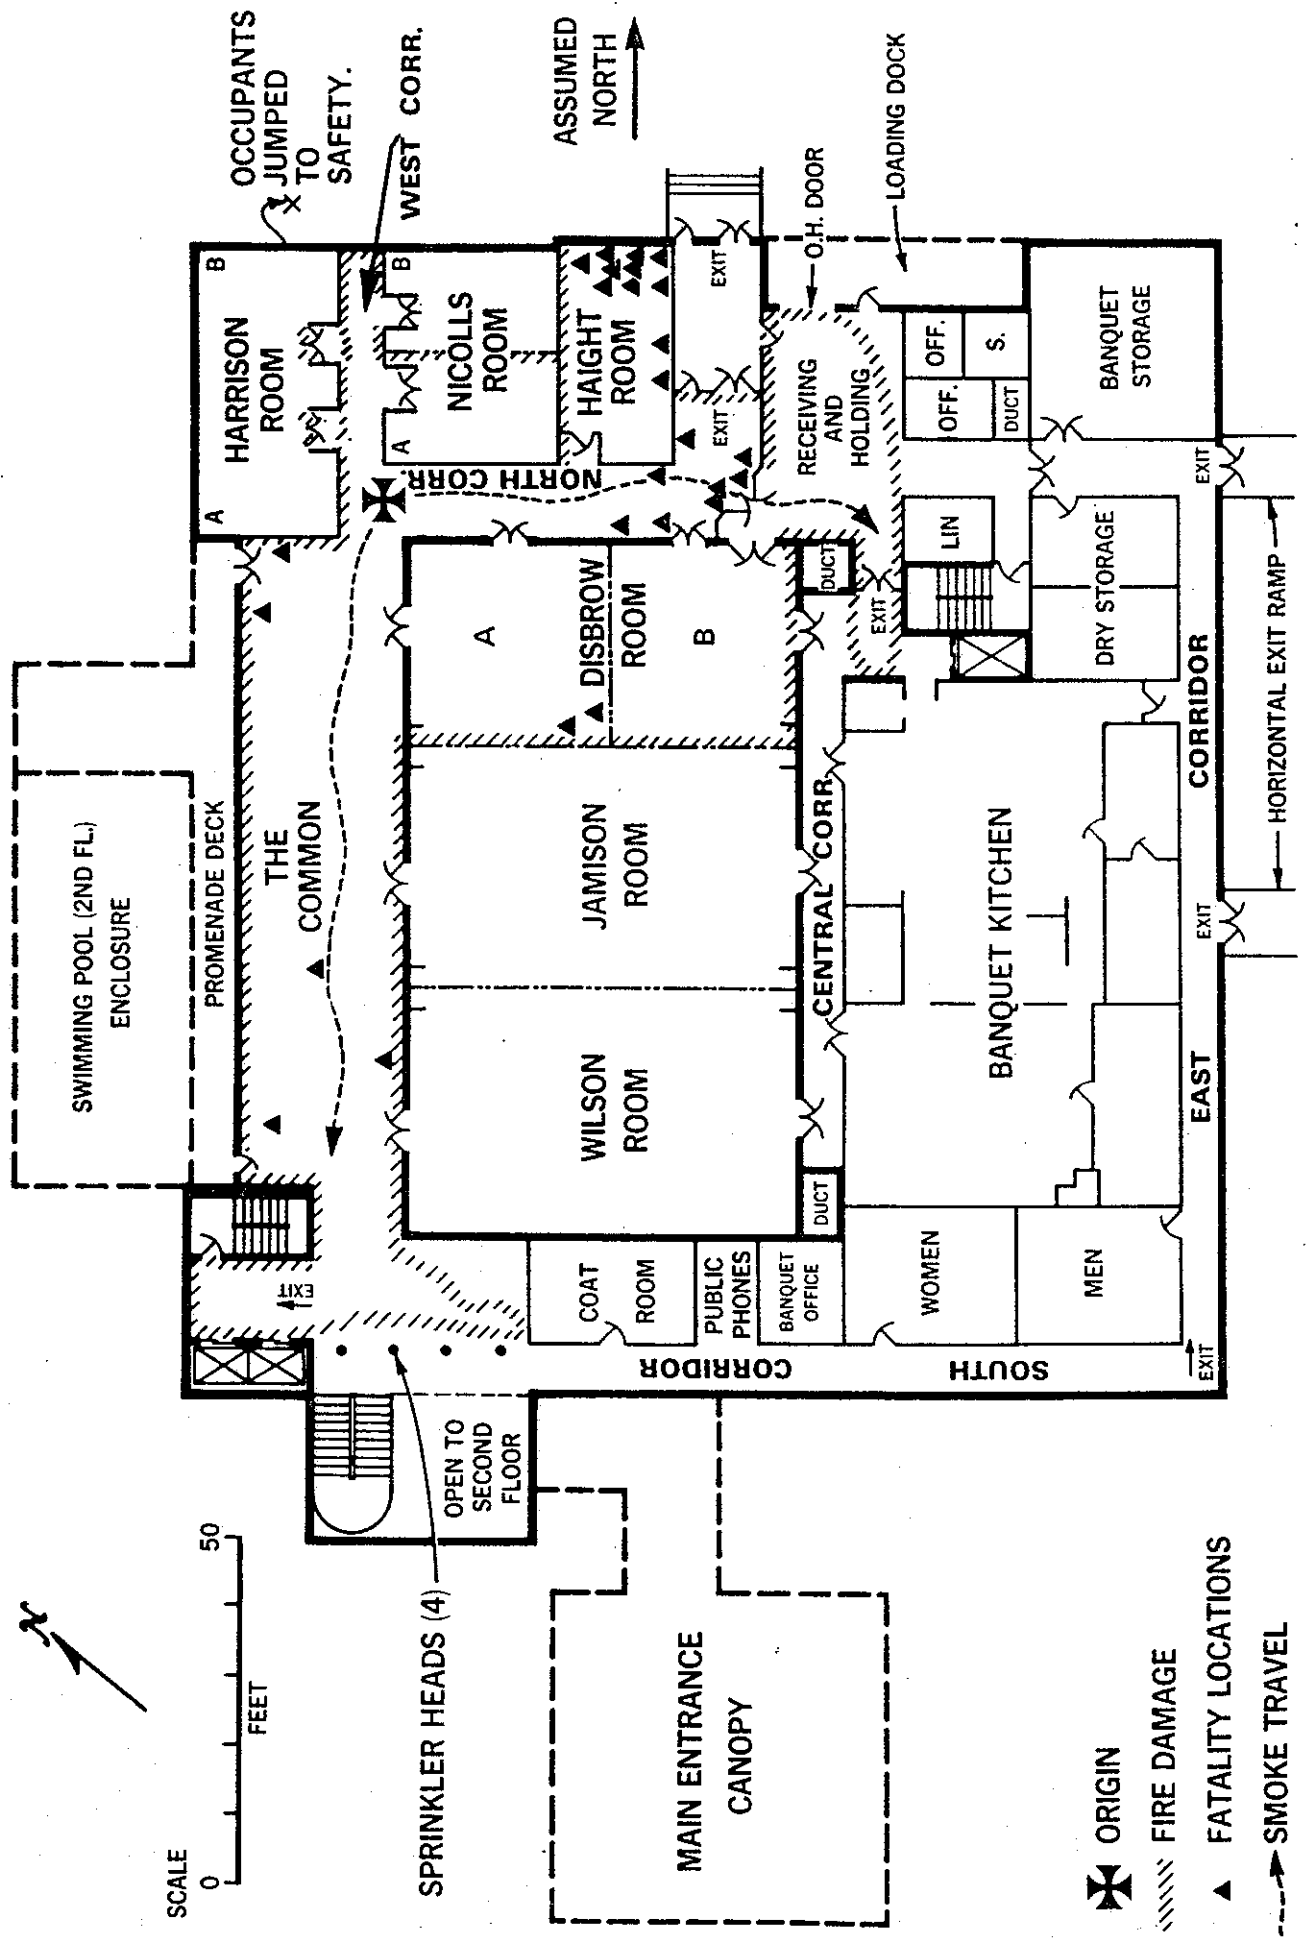
FIGURE 2

The Common served as the focal point and key exit access corridor for the conference facility on the third floor and as a lobby for the Grand Ballroom. The Common provided access to the Wilson Room, Jamison Room, and Disbrow Rooms - - the designations for the meeting rooms that could be created within the Grand Ballroom by movable steel wall partitions. The Disbrow Room on the east end of the Ballroom could be further subdivided into two smaller meeting rooms, Disbrow Rooms A and B, by means of another movable steel wall partition. On the morning of the fire the movable partitions had been extended to subdivide the Ballroom into four meeting areas, three of which were occupied at the time of the fire. (See Figure 2.)

THIRD FLOOR - FIRE RESISTIVE CONSTRUCTION (2 HR.)
